Report No.: HC60204A/2019

Product Description: IP Camera

Style/ Item No.: MS9321-EHV/ No.1

1. Impact Test

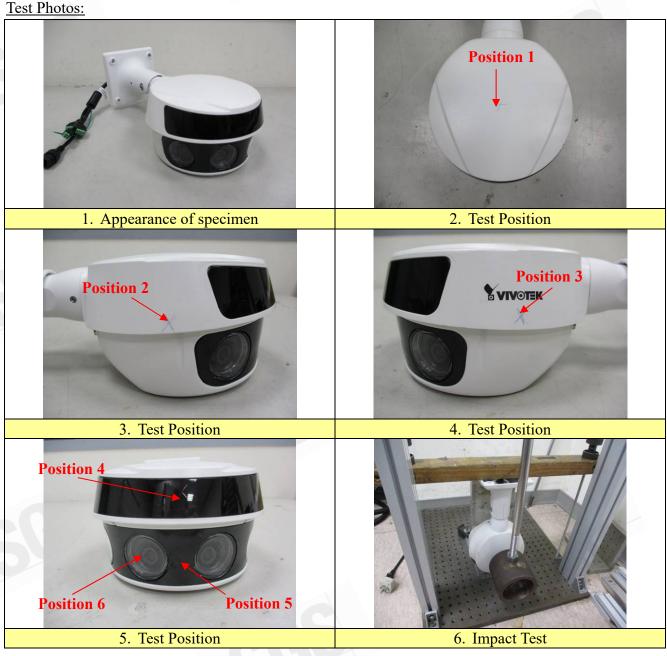
Test Position: Position 1 ~ Position 6 (As shown in photo $2 \sim 5$)

Testing device: As shown in photo 6, 7
