Report No.: HC30038A/2018

Product Description: NETWORK CAMERA

Style/ Item No.: MS9390-HV/ No.1

1. Impact Test

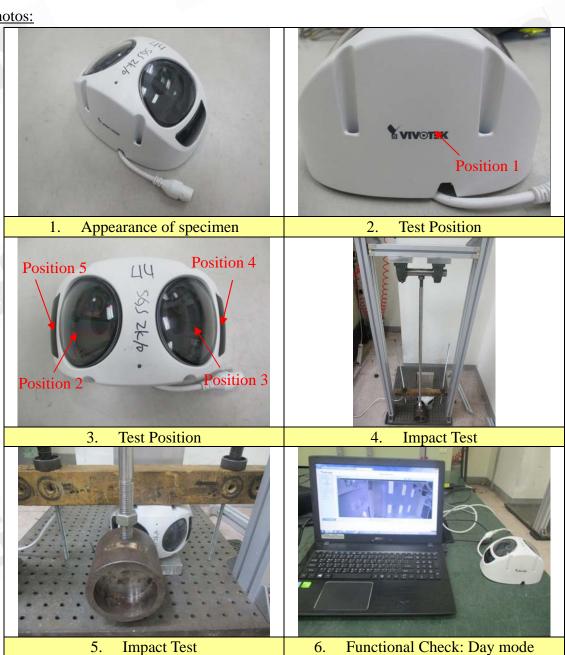
Test Photos:

Test Position: Position 1~ Position 5 (see photo 2, 3)

No. of Impact: 1 impact for position As shown in photo 4, 5 Testing device:

Test method: Refer to IEC 62262 Edition 1.0: 2001--IK10

Impact energy: 20 Joule

Mass: 5 kg

Impact height: 40 cm
