## TEST REPORT

Report No.: HC10168A/2019

Product Description: Network Camera Housing  
Style/ Item No.: SD9374-EHL/ No.1  
Quantity: Total 1 piece  
Testing Period: Sep. 28, 2018  
Note: (Client's declaration) The SD9374-EHLX, SD9364-EH-v3,  
SD9364-EHX-v3, SD9364-EHL-v3, SD9364-EHLX-v3, SD9363-EHL-v3,  
SD9363-EHLX-v3, SD9363-EHL-v2, SD9364-EHL-v2, SD9364-EH-v2,  
SD9366-EH-v2, used the identical enclosure.

## 1. Impact Test:

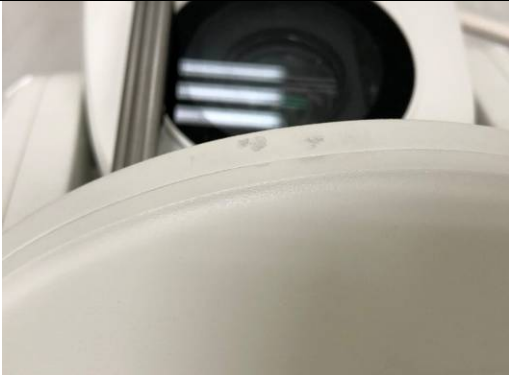
Style/ Item No. Test Position		Check Item	Appearance Check (visual check)	Functional Check
SD9374-EHL/ No.1	Position 1		The cover of specimen dent after this test (see photo 7)	Normal
	Position 2		The cover of specimen dent after this test (see photo 8)	Normal
	Position 3		The cover of specimen dent after this test (see photo 9)	Normal

<p>7. The cover of specimen dent after this test: Test Position 1</p>	<p>8. The cover of specimen dent after this test: Test Position 2</p>

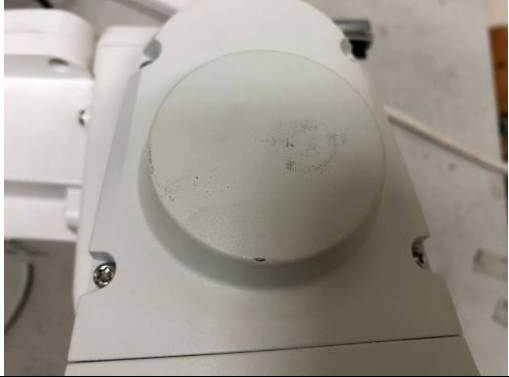
<p>9. The cover of specimen dent after this test: Test Position 3</p>	<p>10. Functional check</p>

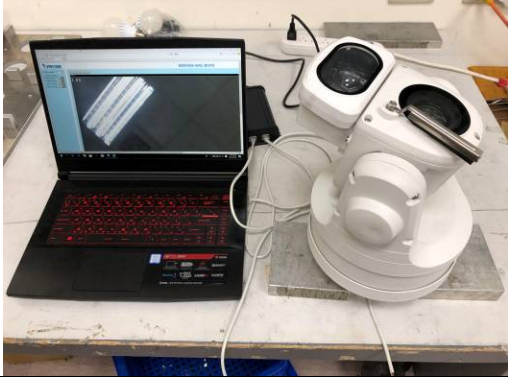
- Examine the appearance of specimen(s) by visual check and perform functional check after this test.
- Functional check: Connect the specimen with rated power and NB via RJ45 port then examine whether the photography function could be work normally or not.
