TEST REPORT

Report No.: HC6144B/2019

Product Description: IP Camera
Style/ Item No.: FD9387-HV/ No.1
Manufacturer/ Vendor: Vivotek Inc.
Country of Origin: Taiwan
Quantity: Total 1 piece
Testing Period: Jun. 25, 2019
Note: (Client's declaration) The FD9387-HV、FD9365-HTV-A、FD9365-EHTV-A、FD9387-HTV-A、FD9387-EHTV-A、FD9365-HTVL、FD9387-HTV、FD9387-EHV、FD9387-EHTV、FD9387-HV(AC)、FD9387-HTV(AC)、FD9387-HTV(W/O LOGO)、FD9387-EHV(AC)、FD9387-EHTV(AC)、FD9387-HVTPM、FD9367-EHTV、FD9367-HTV、FD9367-HV、FD9367-HTV(EPOC)、FD9367-HV(W/O IR)、FD9367-HV(W/O MIC)、FD8377-EHTV、FD8377-HTV、FD9371-EHTV、FD9371-HTV、FD9371-HTV(TILT 80)、FD9381-EHTV and FD9381-HTV used the identical enclosure.

1. Impact Test

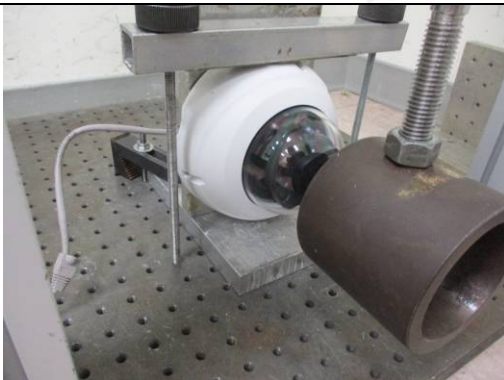
<p>7. Impact Test</p>	<p>8. Appearance of specimen after test</p>

Testing device: As shown in photo 6, 7

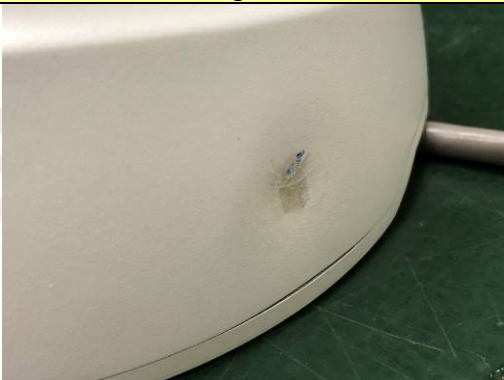
<p>9. Appearance of specimen after test</p>	<p>10. Appearance of specimen after test</p>

Style/ Item No.	Test Position	Check Item	Appearance check (visual check)	Functional Check
FD9387-HV/ No.1	Position 1		No visible damage	Normal
	Position 2		The cover of specimen dented after this test (see photo 8)	Normal
	Position 3		The cover of specimen dented after this test (see photo 9)	Normal
	Position 4		The cover of specimen dented after this test (see photo 10)	Normal

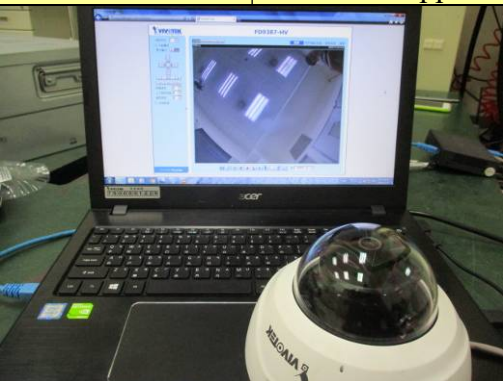
<p>11. Functional Check</p>

- Examine the appearance of specimen(s) by visual check and perform functional check after this test.
- Functional check: Connect the specimen with rated power and NB via RJ45 port then examine whether the photography function could be work normally or not.
