TEST REPORT

Report No.: HC50060B/2019

Product Description: IP Camera
Style/ Item No.: IB9387-HT/ No.1
Quantity: Total 1 piece
Testing Period: May 9, 2019
Note: (Client's declaration) The IB9387-HT, IB9387-EHT, IB9387A-HT and IB9387A-EHT used the identical enclosure.

Test Required: Test for Degrees of Protection Provided by Enclosures (IEC 60529 Edition 2.2: 2013)

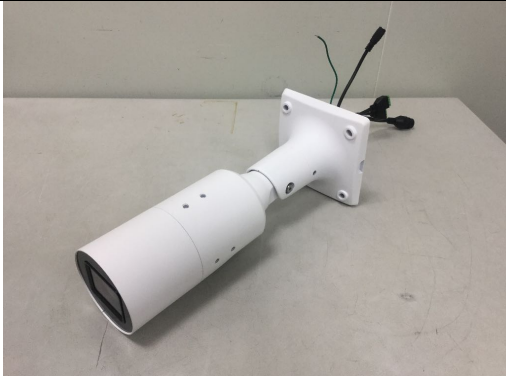
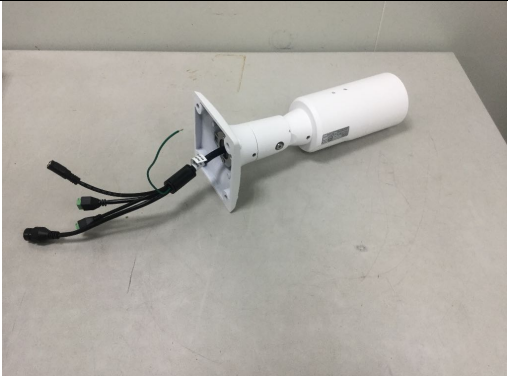
<p>1. Appearance of specimen</p>	<p>2. Appearance of specimen</p>

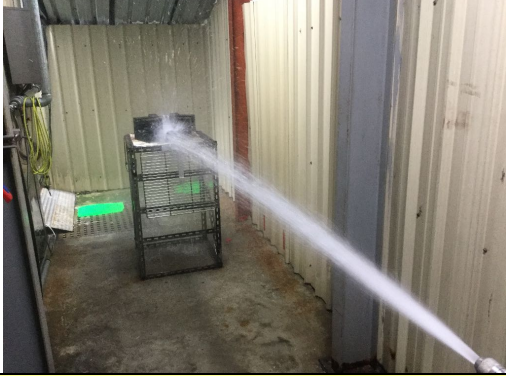
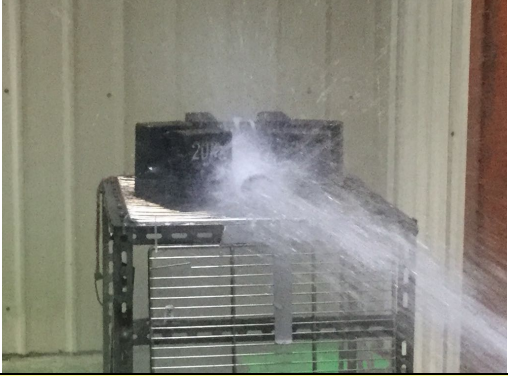
<p>3. Test for protection against water</p>	<p>4. Test for protection against water</p>

Test means: Spraying the enclosure from all practicable directions with a stream of water from a standard test nozzle as specified in test standard.

Internal diameter
of the nozzle: 12.5 mm

Delivery rate: 100 l/minute ±5%

Distance from nozzle
to enclosure surface: between 2.5 m and 3 m

Core of the substantial
stream: circle of approximately 120 mm diameter at 2.5 m distance from nozzle

Test duration: Total 3 minutes
