TEST REPORT

Report No.: HCO0134B/2019
Page: 1 of 5
Date: November 5, 2019

Product Description: IP Camera
Style/ Item No.: IB9365-HT-A (12~40mm)/ No.1
Quantity: Total 1 piece
Testing Period: Oct. 30, 2019

1. Impact Test

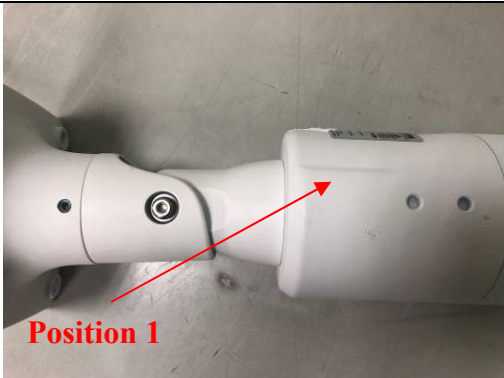
<p>Position 1</p>
<p>1. Appearance of specimen</p>	<p>2. Test Position</p>

Impact height: 400 mm

Test Position: Position 1 ~ Position 3 (As shown in photo 2 ~ 4)

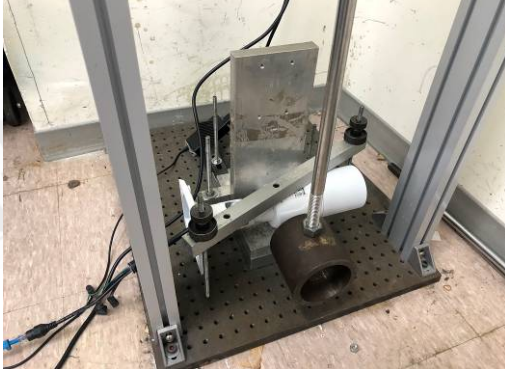
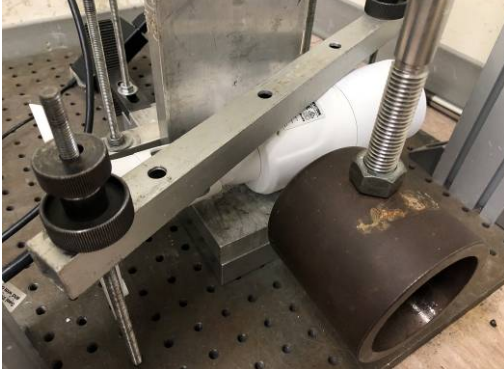
<p>5. Impact Test</p>	<p>6. Impact Test</p>

Impact energy: 20 Joule

Mass: 5 kg

Testing device: As shown in photo 5, 6

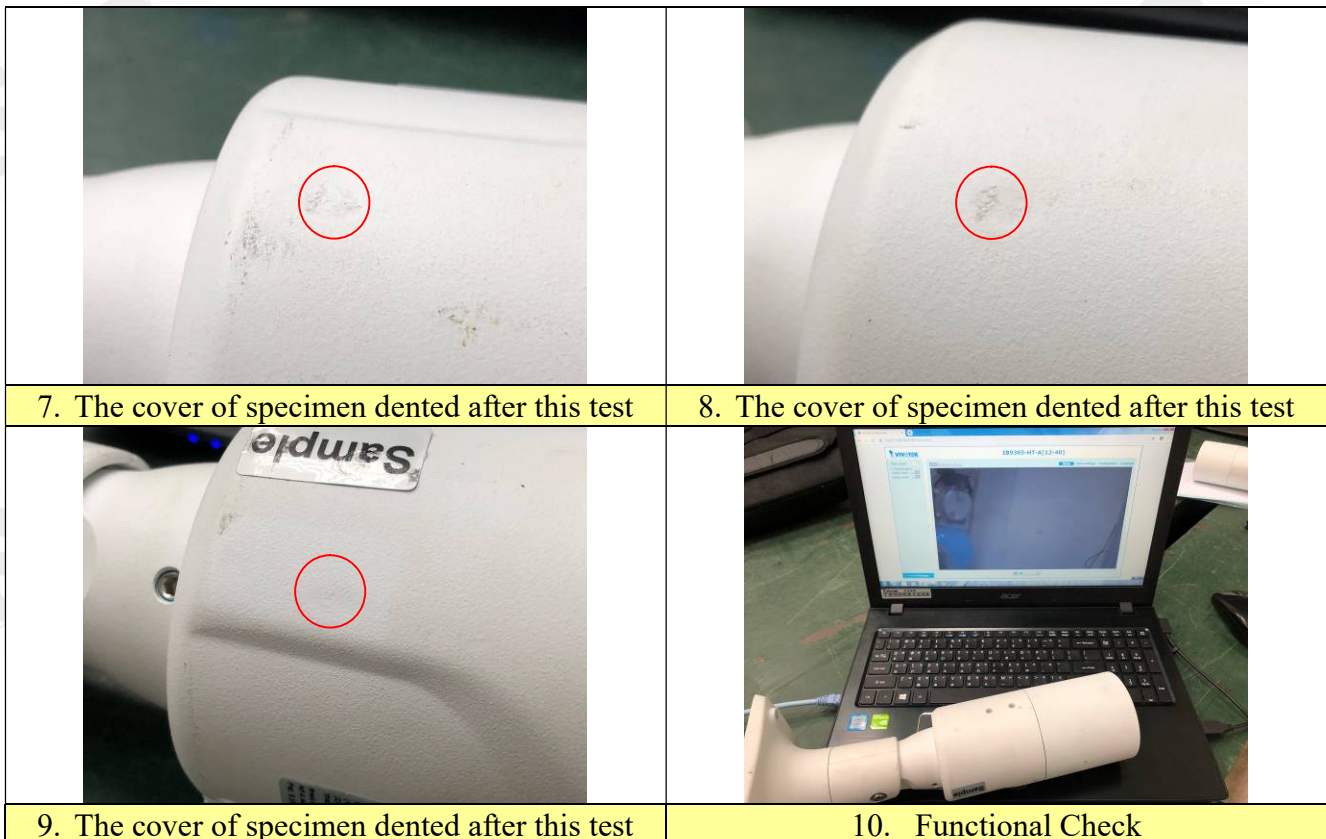
Style/ Item No.	Test Position	Check Item	Functional Check
		Appearance check (visual check)	
IB9365-HT-A (12~40mm)/ No.1	Position 1	The cover of specimen dented after this test. (see photo 7)	Normal
	Position 2	The cover of specimen dented after this test. (see photo 8)	Normal
	Position 3	The cover of specimen dented after this test. (see photo 9)	Normal
