TEST REPORT

Report No.: HC70221A/2019

Product Description: IR Dome Camera
Style/ Item No.: FD9360-H/ No.1
Manufacturer/ Vendor: Vivotek Inc.
Country of Origin: Taiwan
Quantity: Total 1 piece
Testing Period: Aug. 6, 2019
Note: (Client's declaration) The FD9360-H and FD9380-H used the identical enclosure.

1. Impact Test:

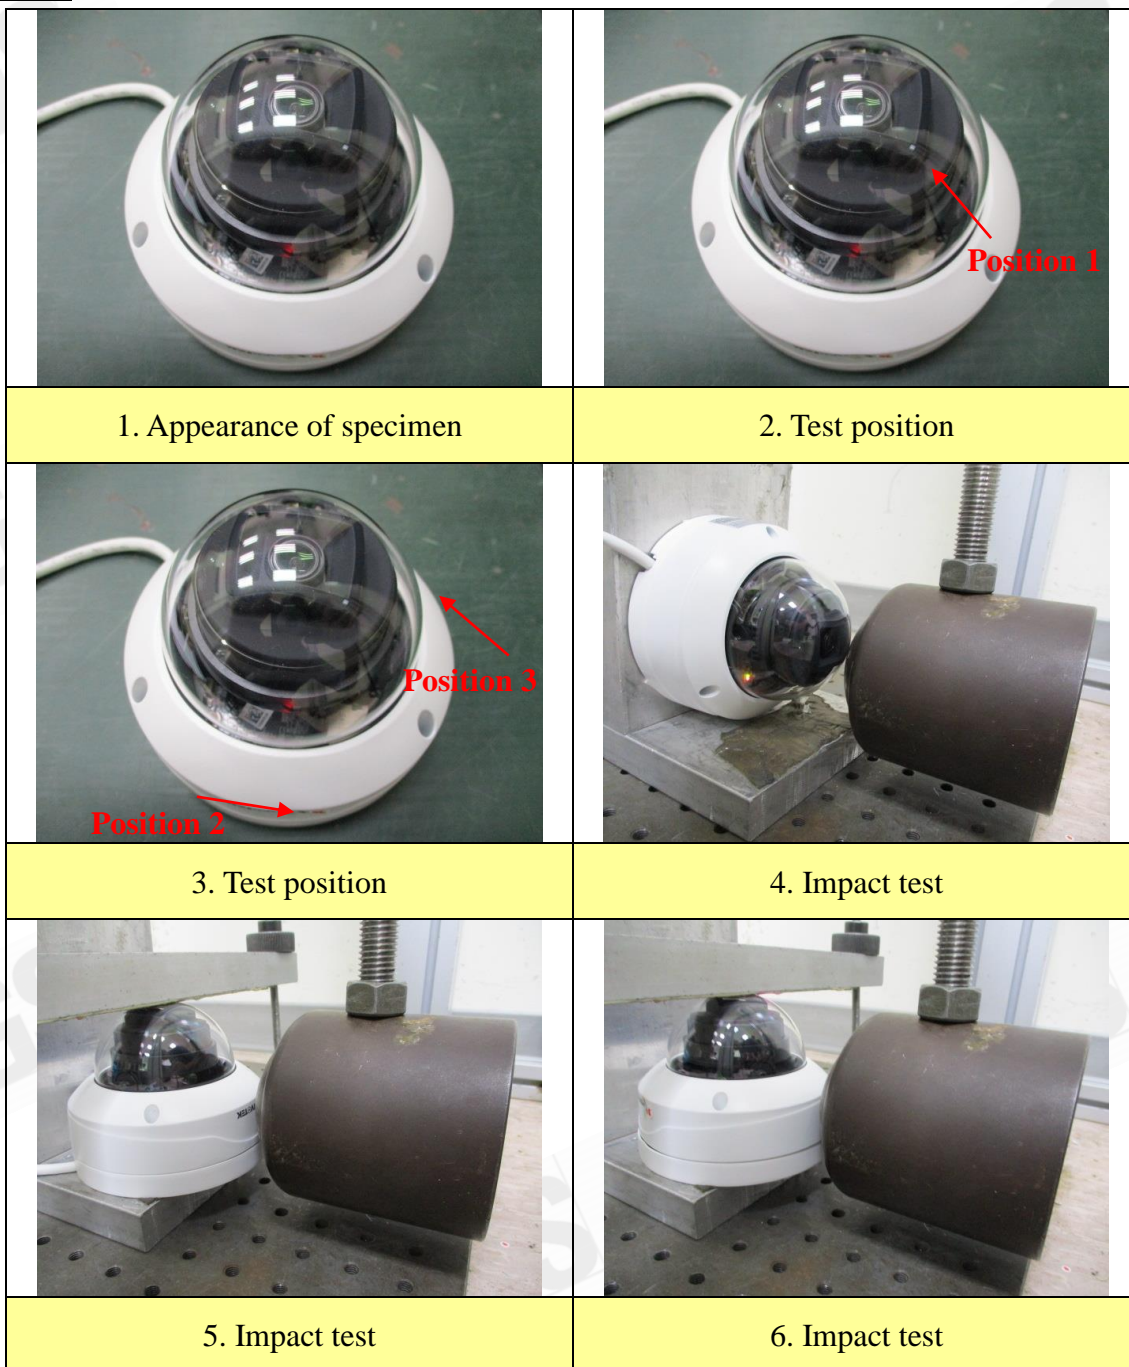
Test Photos:

Test Position: Position 1 ~ Position 3 (As shown in photo 2, 3)

Testing device: As shown in photo 4, 5 and 6

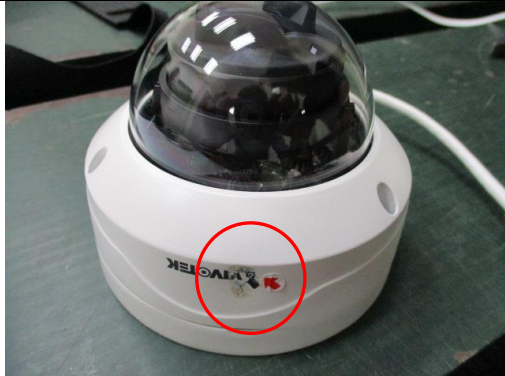
Style/ Item No.	Test Position	Check Item	Appearance Check (Visual Check)	Functional Check
		FD9360-H/ No.1	Position 1	
Position 2			The cover of specimen dented after this test. (see photo 7)	Normal
Position 3			The cover of specimen dented after this test. (see photo 8)	Normal

<p>7. The cover of specimen dented after this test</p>	<p>8. The cover of specimen dented after this test</p>

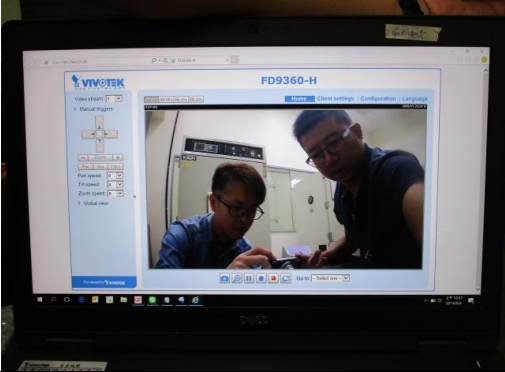
- Examine the appearance of the specimen(s) by visual check and perform functional check after this test.
- Functional check: Connect the specimen with rated power and NB via RJ45 port then examine whether the photography function could be work normally or not.

<p>9. Functional check</p>
