TEST REPORT

Report No.: HC30219/2019

Product Description: Network Camera
Style/Item No.: FD9389-HV/ No.1;
FD9389-HMV/ No.1;
FD9389-HTV/ No.1

1. Impact Test

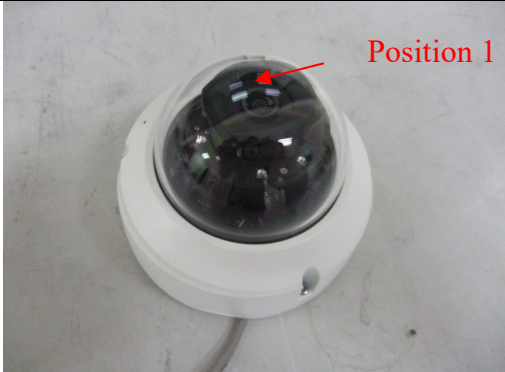
<p>1. Appearance of specimen: FD9389-HV/ No.1</p>	<p>2. Appearance of specimen: FD9389-HMV/ No.1</p>

Test Position: Position 1 (as shown in photo 1 ~ 3)

Style/ Item No.	Check Item	Appearance Check (Visual check)	Functional Check
FD9389-HV/ No.1		No visible damage	Normal
FD9389-HMV/ No.1		No visible damage	Normal
FD9389-HTV/ No.1		No visible damage	Normal

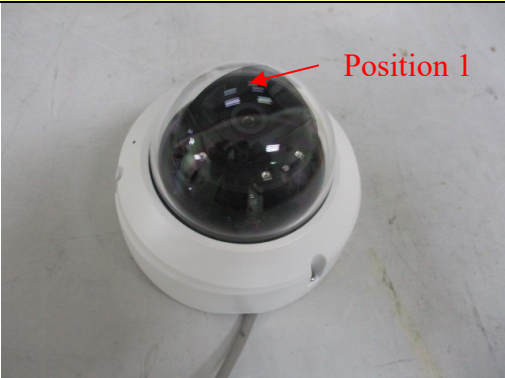
<p>3. Appearance of specimen: FD9389-HTV/ No.1</p>	<p>4. Impact Test: FD9389-HV/ No.1</p>

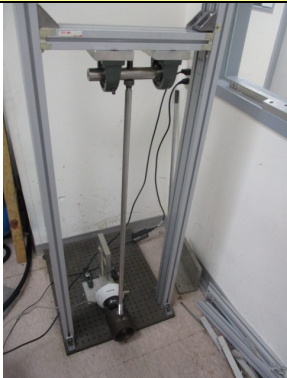
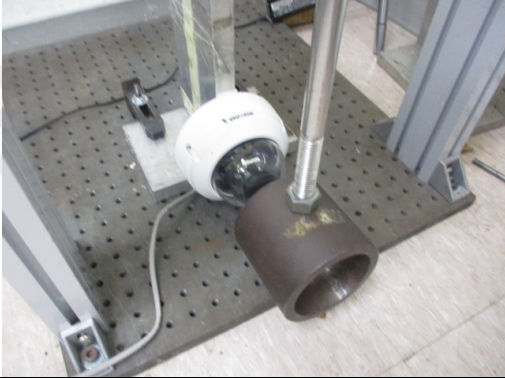
<p>5. Impact Test: FD9389-HV/ No.1</p>	<p>6. Impact Test: FD9389-HMV/ No.1</p>

Test method: IEC 62262 Edition 1.0: 2002--IK10

Impact energy: 20 Joule

Mass: 5 kg

Impact height: 40 cm

Testing device: As shown in photo 4 ~ 9

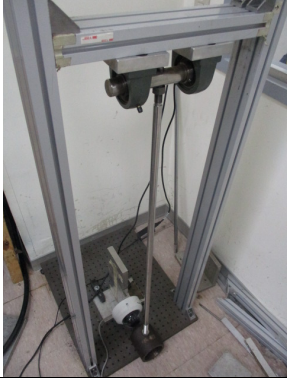
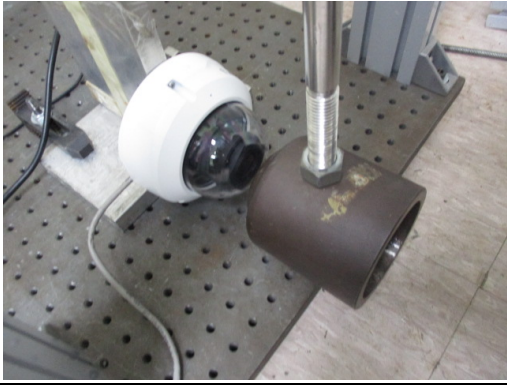
<p>7. Impact Test: FD9389-HMV/ No.1</p>	<p>8. Impact Test: FD9389-HTV/ No.1</p>

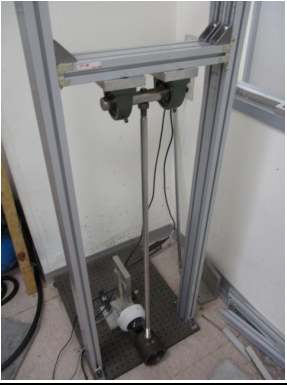
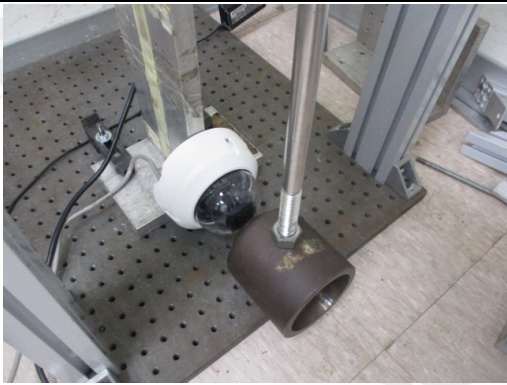
<p>9. Impact Test: FD9389-HTV/ No.1</p>	<p>10. Functional check: FD9389-HV/ No.1</p>

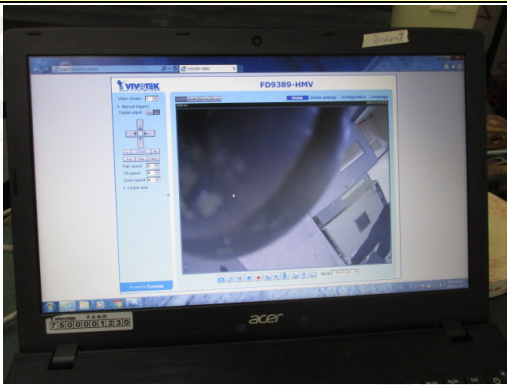
<p>11. Functional check: FD9389-HMV/ No.1</p>	<p>12. Functional check: FD9389-HTV/ No.1</p>

- Examine the appearance of specimen(s) by visual check and perform functional check after this test.
- Functional check: Connect the specimen(s) with POE and NB via RJ45 port separately then examine whether photograph function could be work normally or not.
