Report No.: HC20011A/2017

**Product Description:** Network Camera

MD8565-N/No.1 Style/Item No.:

1. Impact Test

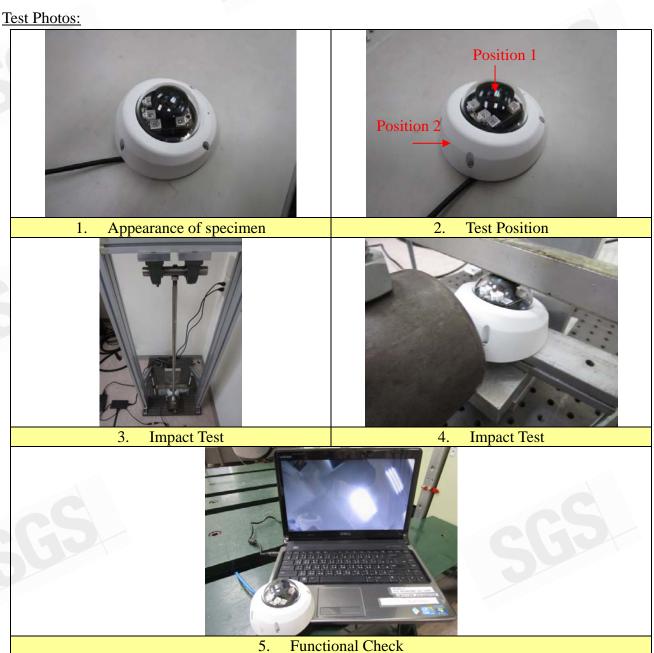
**Test Position:** Position 1 ~ Position 2 (see photo 2)

As shown in photo 3, 4 Testing device:
