TEST REPORT

Report No.: HCO0162A/2017

Product Description: Network Camera
Style/Item No.: FD9367-HT/ No.1
Manufacture/Vendor: Vivotek Inc.
Country of Origin: Taiwan
Quantity: Total 1 piece
Testing Period: Nov. 1, 2017
Note: (Client's declaration) The FD9367-HT, FD9367-EHTV, FD9367-HTV, FD9367-HV, FD8377-EHTV, FD8377-HTV, FD9371-EHTV, FD9371-HTV, FD9381-EHTV and FD9381-HTV used the identical enclosure.

1. Impact Test

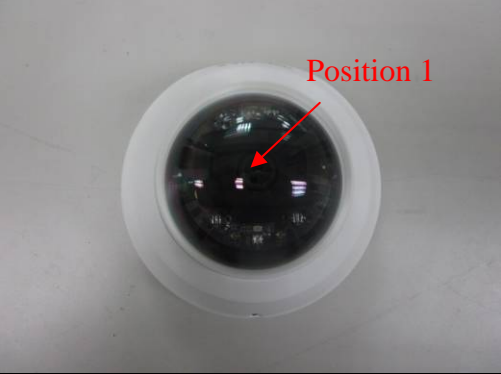
Test Position: Position 1 (as shown in photo 1)

<p>1. Appearance of specimen</p>	<p>2. Functional Check</p>

Style/ Item No.	Check Item	Appearance Check (Visual check)	Functional Check
FD9367-HT/ No.1		No visible damage	Normal

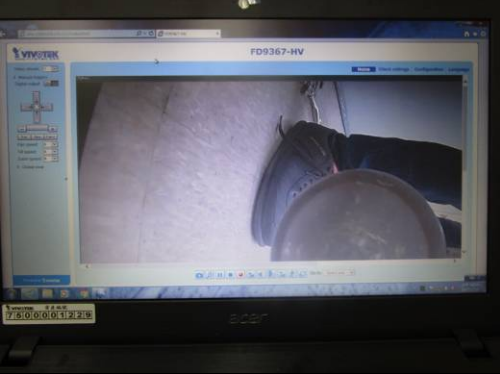
- Examine the appearance of specimen(s) by visual check after this test.
- Functional check: Connect the specimen with rated power and Notebook via RJ45 port then examine whether the photograph function could be work normally or not.

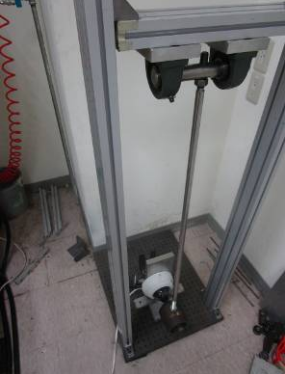
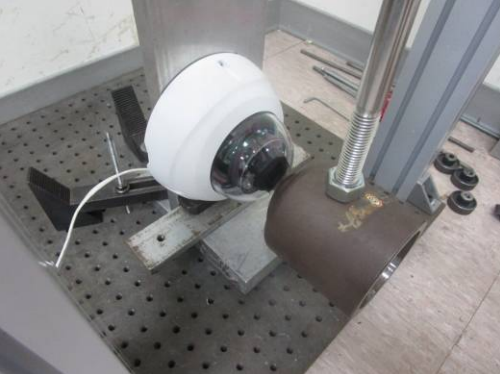
Test method: IEC 62262 Edition 1.0: 2002--IK10

Impact energy: 20 Joule

Mass: 5 kg

Impact height: 40 cm

Testing device: As shown in photo 3, 4

<p>3. Impact Test</p>	<p>4. Impact Test</p>
